Newsletter

July 2022

Wa165 Maintenance.

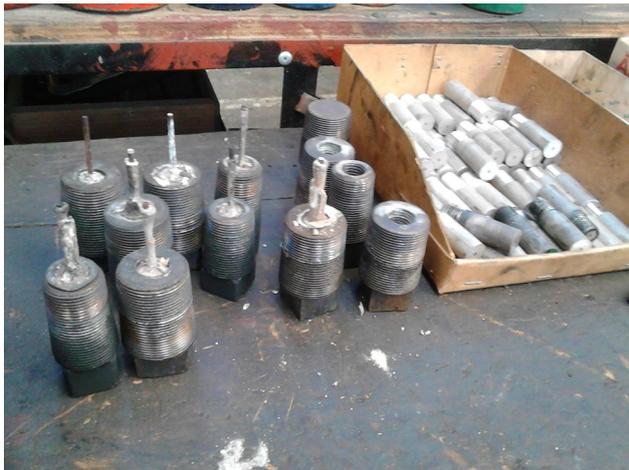
The boiler plugs at the end of the season.

The amount that the anodes deteriorate during an operating season (and therefore the protection they provide to the boiler) is clear to see.

Following the removal of the boiler plugs, the remains of the sacrificial anodes were removed from the plugs and new anodes fitted to the plugs.

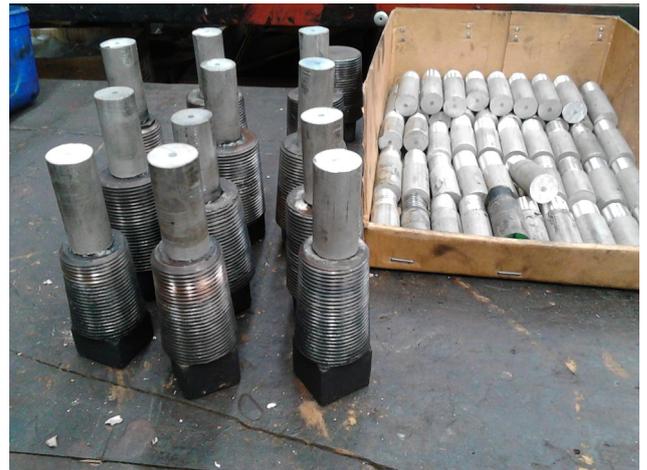
The boiler plugs fitted with new anodes.

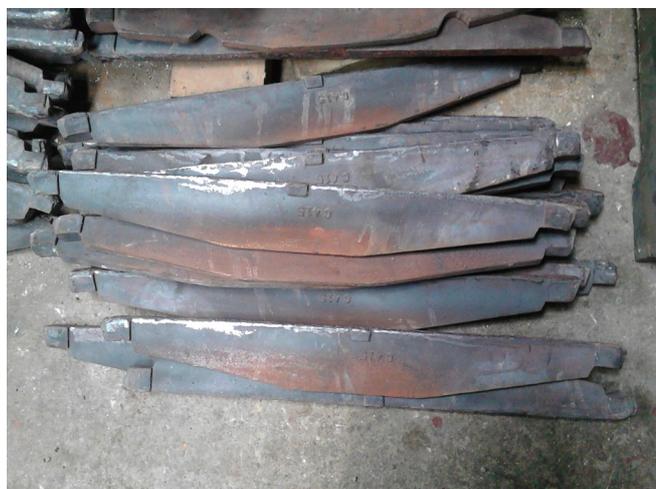
The cleaned fire bars.

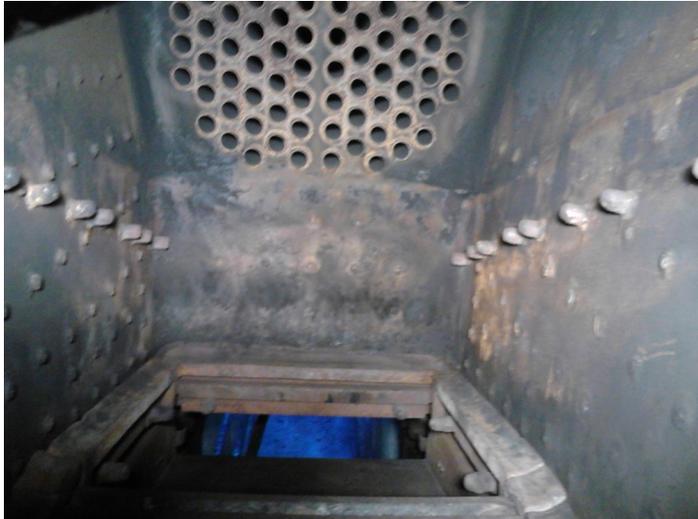
The fire box is currently empty as the fire bricks and the fire bars have all been removed.

The eight fire bricks rest on horizontally-protruding studs, that can be seen in the *empty fire box* photo below. They form an arch over the top of the fire box which blocks the view of the boiler tubes. With the fire bricks removed, it will be easier to carry out the cold boiler inspection.

The empty fire box.

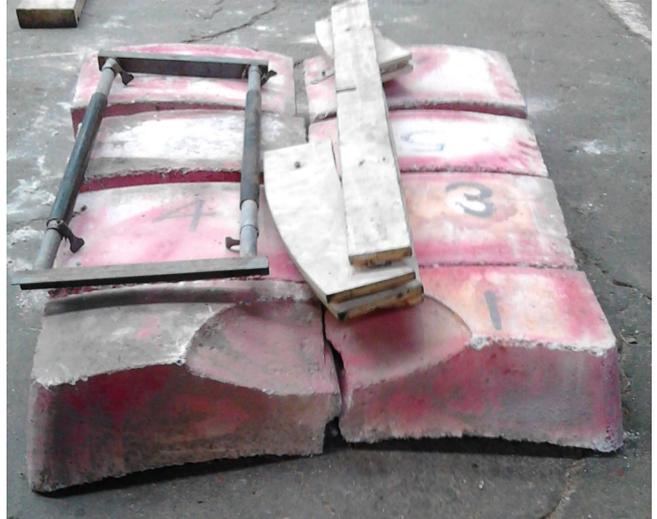
The old fire bricks which form the brick arch that have been removed, shown with the installation tools to install the new fire bricks.

This will be the second time that the fire bricks have been replaced since Wa165 was first steamed up in 1999 following the major restoration.
