Newsletter

August 2022

Workshop Catch-up

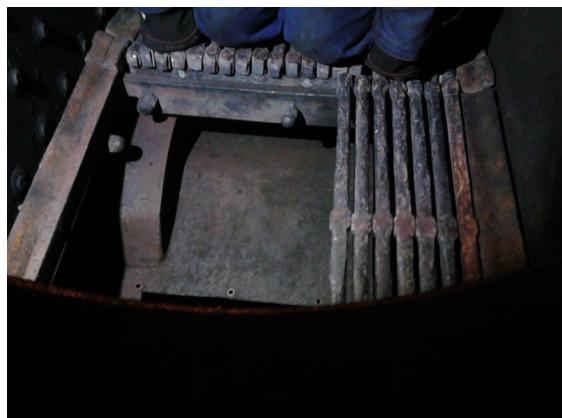
The new fire bricks are being fitted. The main requirement for this job is someone small enough to get inside the fire box - the “volunteer” this time was Geoff. It must be noted that larger steam engines such as the Ab and Ka series engines have much bigger fire boxes!

Firstly, to make it easier to work inside the fire box, the fire bars (which co-incidentally Geoff had previously cleaned) were refitted.

Here the front fire bars have been fitted (and are being used for kneeling on) and half of the rear fire bars are also in place.

The ash pan can be seen underneath the fire bars.

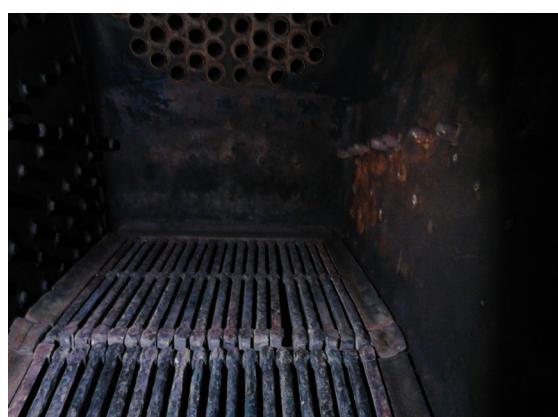
Here, all of the fire bars are now in place.

The boiler tubes are still visible as the brick arch has not yet been fitted.

Some of the studs which hold the arch in place on the right-hand wall can just been seen.

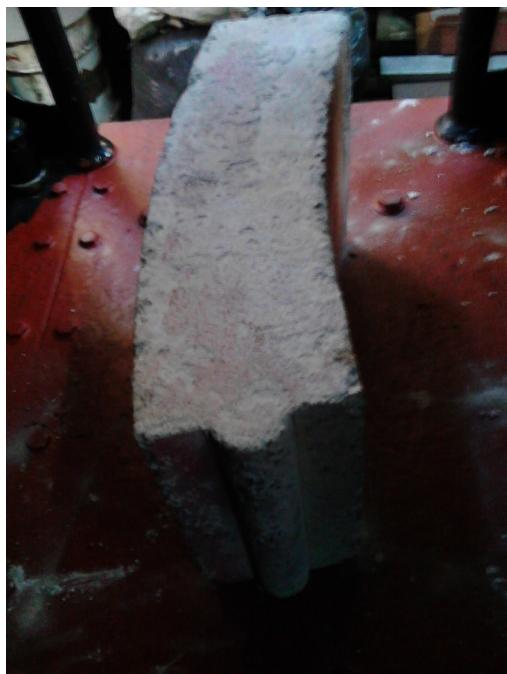
The fire bricks themselves are individually moulded.

The bricks are all curved. The left-hand ones (one of which is shown here) have a protruding piece that fit into a slot on the right-hand ones.

These fittings, together with the curvature of the bricks and the wall studs that they sit on, ensure that the bricks form a self-supporting arch, restricting the area that the fire can occupy.

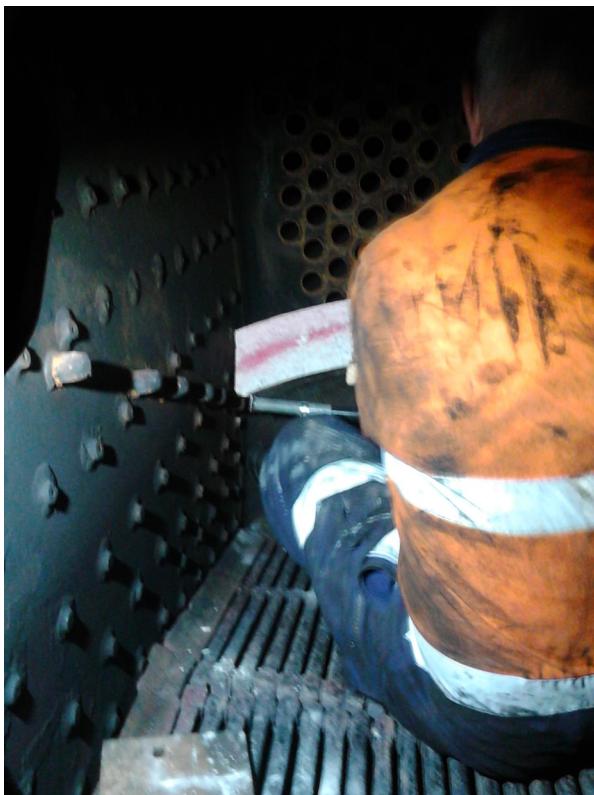
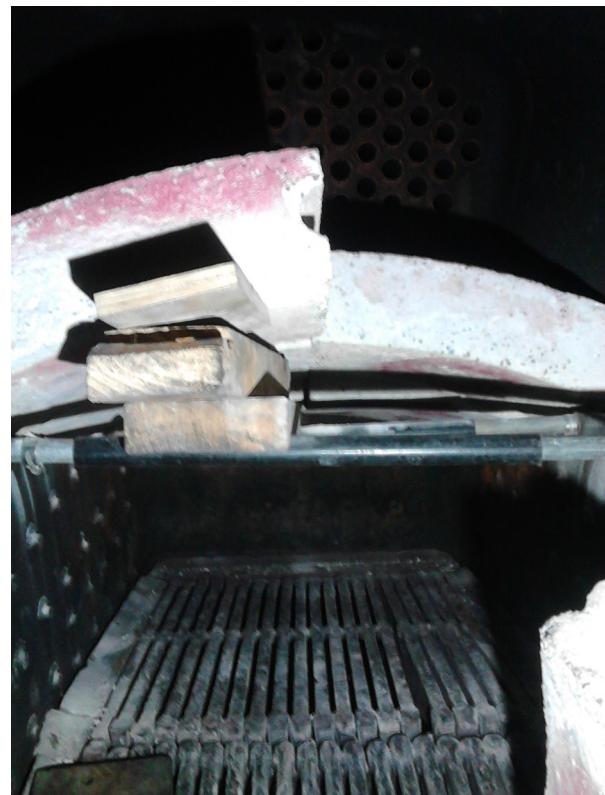
A metal frame and wood packers (see below) are used to temporarily support the left-hand side brick until the appropriate right-hand side brick is slotted in to place.

In the left-hand photo, the left wall supporting studs can clearly be seen. These studs are positioned higher at the rear of the fire box and descend at an angle towards the front of the fire box.

In the right-hand photo, three complete rows of bricks have been fitted and only the final right-hand brick remains to be fitted. The left-hand brick of the final row is supported by the metal frame and wood packers at the moment.

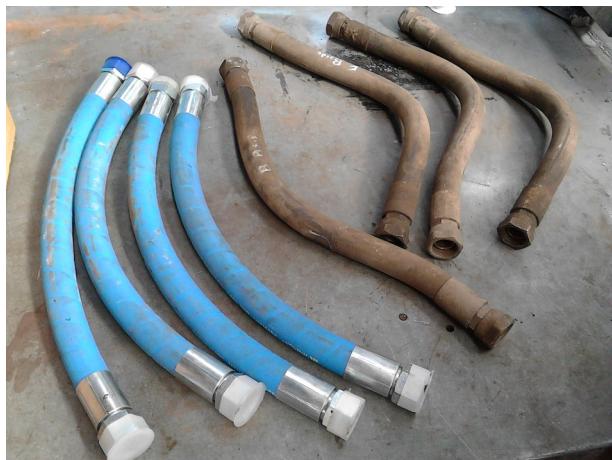
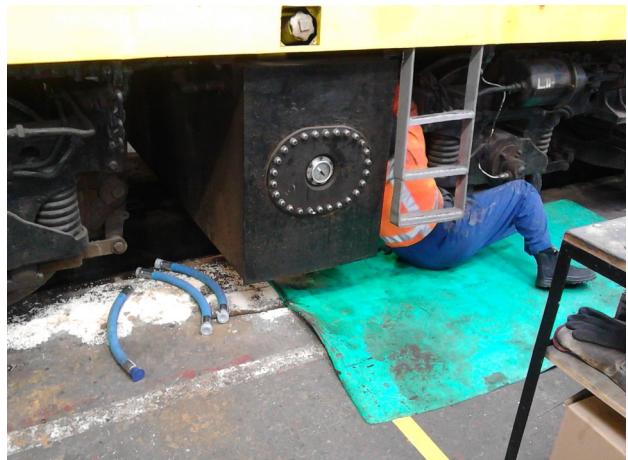
The new brake hoses arrived towards the end of last month and have now been fitted. (Some jobs are easier to do than others!)

An “interesting” point about the thinking of NZR (as it was then) is that due to the size of the fittings, 1250psi hose has to be fitted, even though only 100psi pressure is required. The 1250psi hose is of course dearer than 100psi hose!

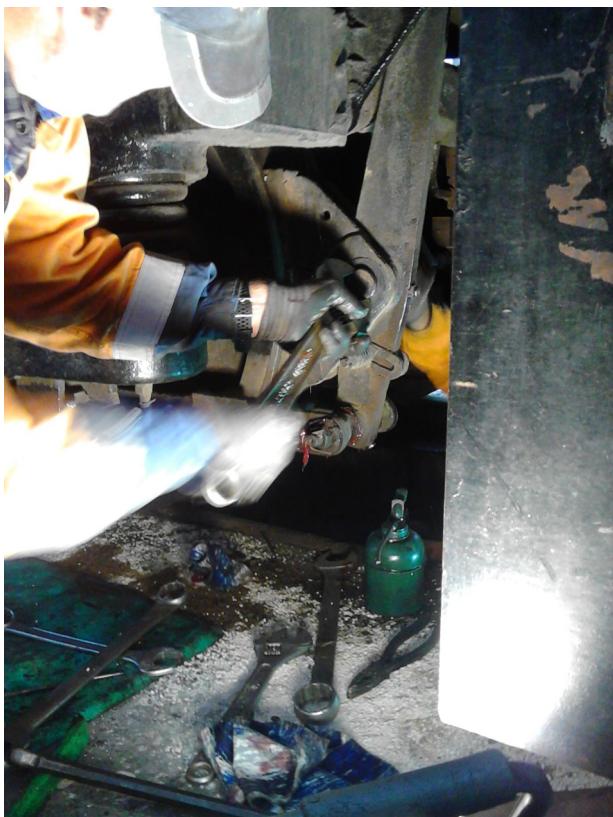
Work in Progress

A complete check of all the lubricating points on the running gear has been carried out. Some of the lubricating points were blocked by ages-old grease and dirt, so they had to be cleaned out properly. In some places this entailed the removal of some linkages and pins – not what was originally planned!

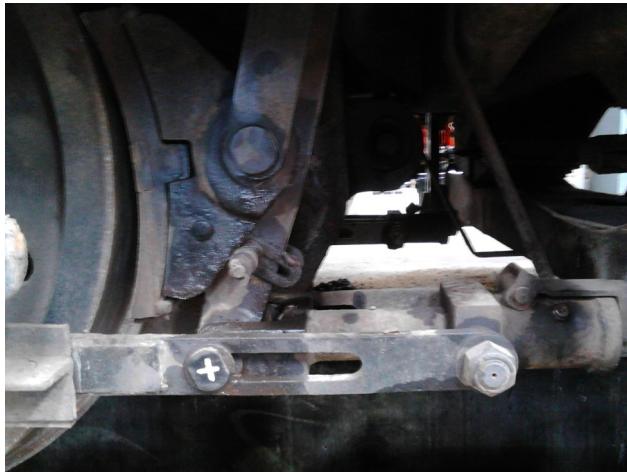
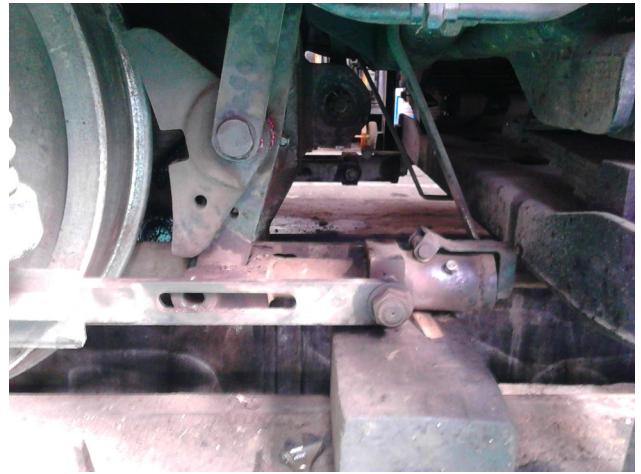
A close inspection of the brakes revealed excess wear on one of the brake caliper assemblies. The assembly was dismantled and some replacement items had to be manufactured in the workshop (see below).

Further inspection has revealed that some of the other locating pins also need to be replaced.

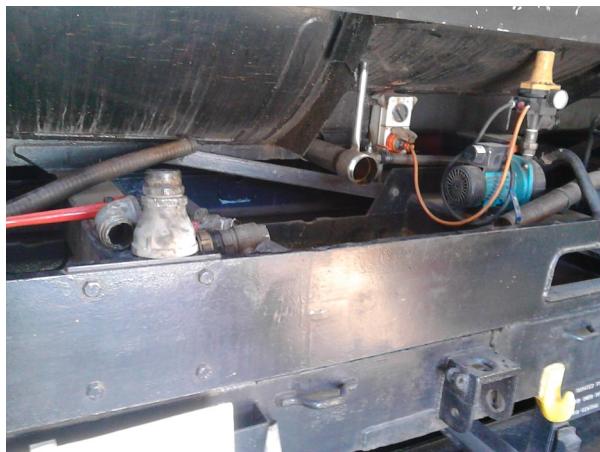
The output piping from the fresh water tank on the service wagon has also been receiving some attention.

Despite the water tank being used to carry only rain water or, occasionally, treated and filtered town supply water, an inspection revealed a build-up of sludge in the output piping. Not a good idea for this sludge to end up in the boiler of Wa165!

So, portions of the external piping and associated fittings have been replaced with new items.
