Newsletter September 2022

Workshop Catch-up

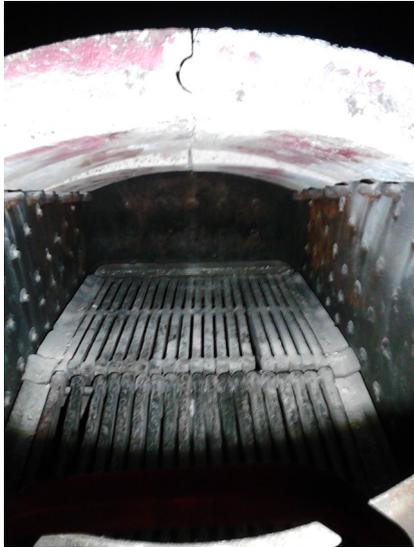
Wa165 Maintenance

The last fire brick has been fitted into place – it caused more trouble than all of the others combined, as it had to be removed and trimmed three times before it slotted into place properly. Geoff was quite pleased to see it finally in place!

The remaining fire bars (Geoff removed some to make it easier for him to work inside the fire box) have been fitted ready for the first firing with the new bricks in place. They will not remain white with red bits for very long!

The boiler plugs have been re-fitted, the cab floor has been repainted and the wooden deck boards refitted.

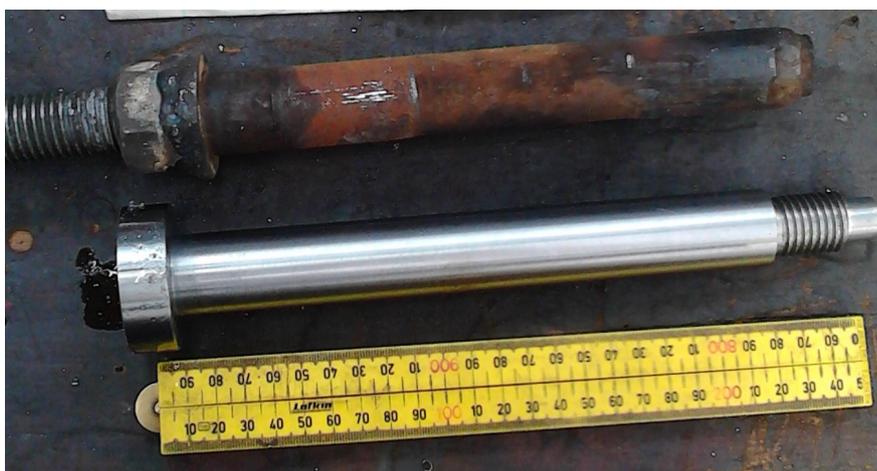
5 (out of the 16) mounting pins were badly worn (*see below*) and have had to be replaced. The remaining mounting pins have all been lubricated.

(Photo Left) A worn mounting pin is at the top.

The replacement pin below it still has to have the head milled to a spanner fitting.

Fortunately using their own personal workshop equipment as well as our workshop facilities, Joe and Danny have been able to manufacture replacement pins and washers.

A lubricating hole will be drilled part-way along the length of the bolt and a grease nipple fitted to enable grease to be pumped into the brake mounts.

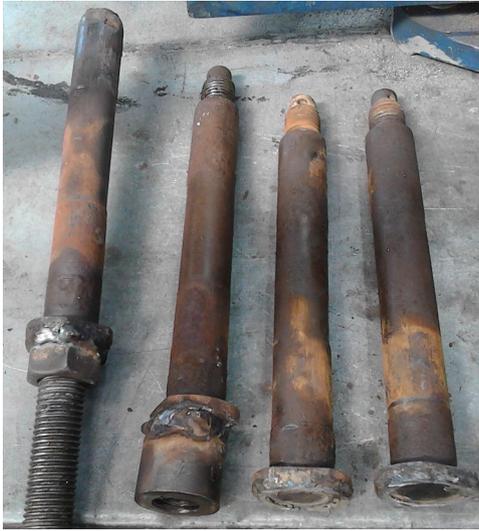
The first pin (in the photo on the previous page) came out relatively easily, but removing the other old, rusty, non-lubricated pins proved to be a real challenge.

In the end, a 60 tonne puller had to be used, which even stretched the threaded section of the pin shown (*photo left*) before the pin finally moved.

Fortunately the pins were so tight that they only came out slowly (not with a sudden explosive-type movement), even with the nearly 60 tonne pulling force used.

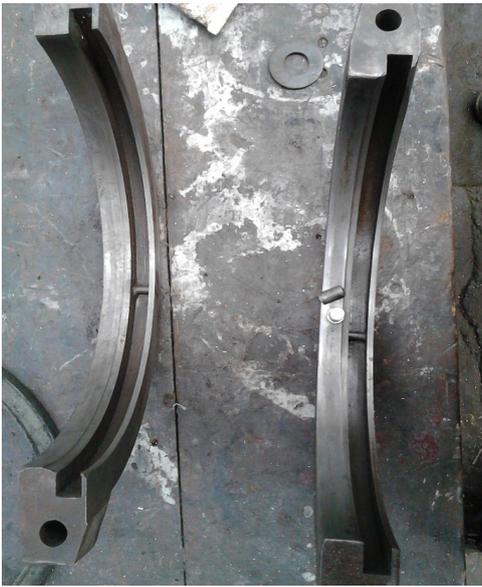
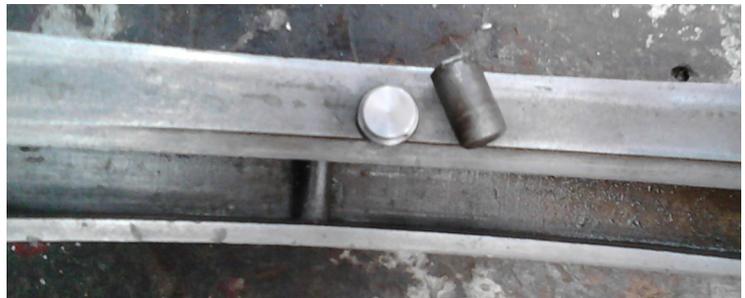
While working on the brake calipers, it was found that an axle suspension bearing dust guard had a broken locating pin, so Joe has made a replacement pin.

Wear marks on the dust guard suggest that the pin had been broken for a while, allowing the dust guard to rotate freely.

Left - One complete axle suspension bearing dust guard (the 2 sections bolt together)

Below - Close-up of broken and replacement locating pins

Further inspection revealed that another two complete dust guards (out of the eight normally installed) were missing, allowing dust and dirt etc. into the traction motors. We need to obtain replacement items.

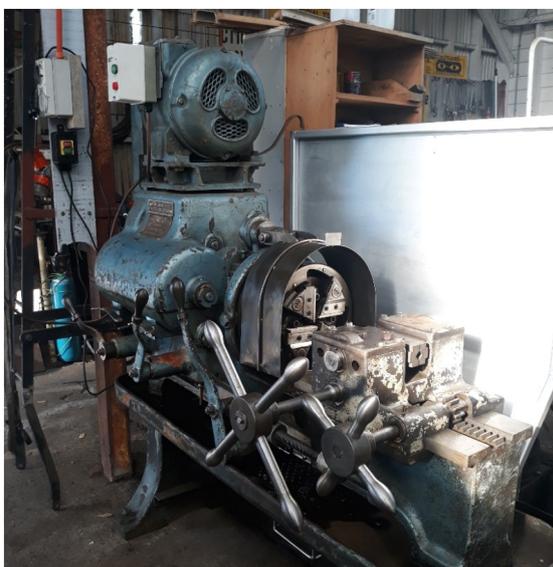
Photo 1:

Overall view showing motor, gearbox, cutting head and vice.

A gear change lever was received broken, and this was brazed to repair. A rack for the new cutting oil circulation system was constructed and fitted under the chip tray. The gearbox was drained and flushed with diesel and kerosene, and filled with 20 litres of new gear oil. The back chip guard was cleaned, painted and refitted to the machine. The head had a 1/2" x 13 tpi grub screw missing, and a replacement was made and fitted.

A start/stop contactor was tested and wired up to the 3 hp, 3 phase motor which is mounted on top of the gearbox. Power is transmitted to the gearbox by twin V-belts. The machine was test run (without cutting), and the 6 available output speeds were measured to understand the gear lever combinations. There are 6 cutting head speeds ranging from 30 rpm to 145 rpm at an increment factor of about 1.4. The gearbox runs very quietly. There are no oil slingers, but filled to below the split line, oil seems to be getting to where it needs to.

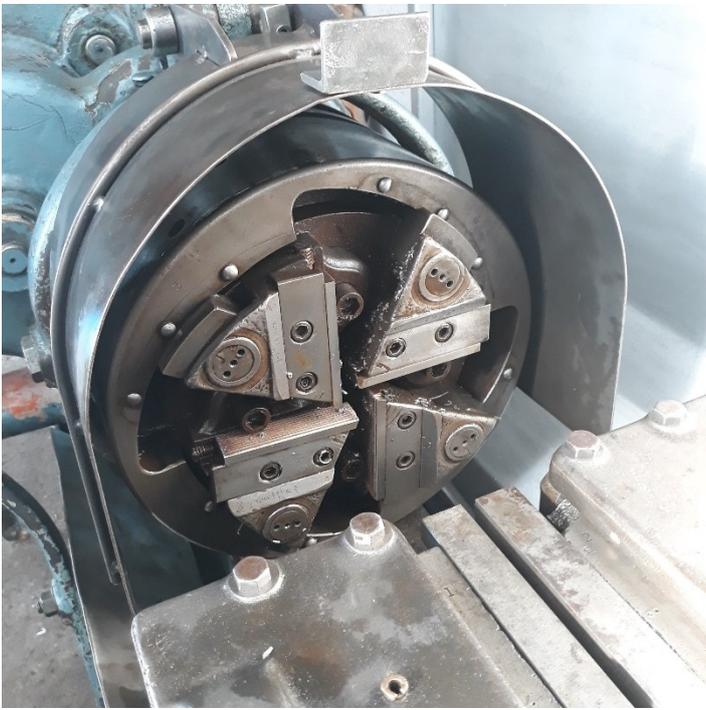
Photo 2:

A closer look at the cutting head in the open position.

The head rotates anti-clockwise, and the 4 tangential tools cut the thread in much the same way as a manual tool does.

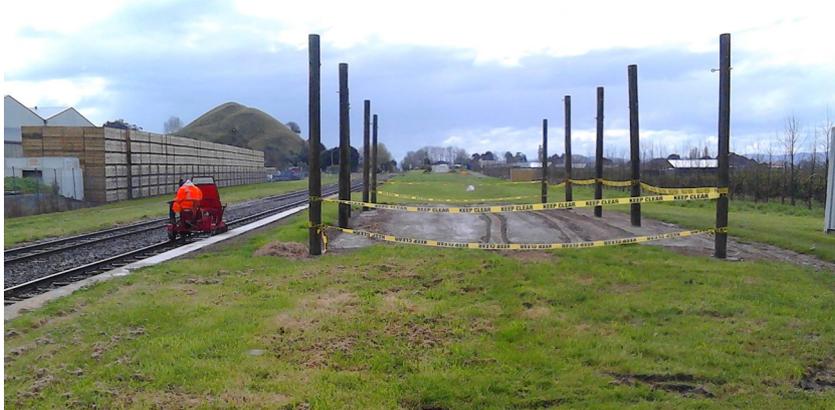
Out at Muriwai, the ground beneath the shade sails has been slowly settling over the years creating uneven areas where the tables and chairs are placed.

Once again David Stokes & his family have offered to help us at Muriwai, this time by levelling the ground underneath the matting.
